INDOOR AIR QUALITY ASSESSMENT

**Samuel Bowles Elementary School
Bowles Park
Springfield, Massachusetts**

Prepared by:
Massachusetts Department of Public Health
Bureau of Environmental Health Assessment
February, 2002

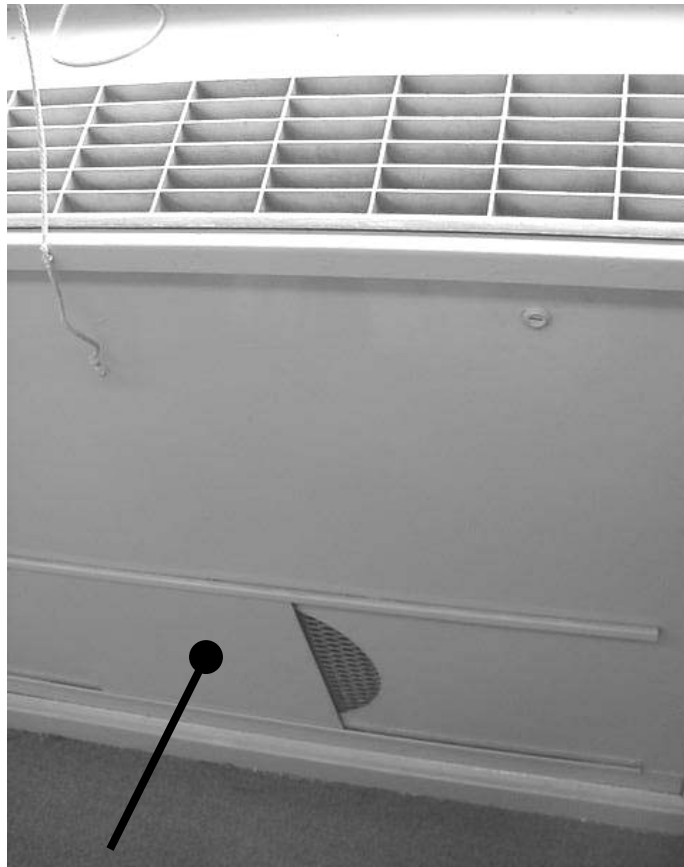
Picture 8

Sliding Panel on Return Vent of the 1925 Wing Univents

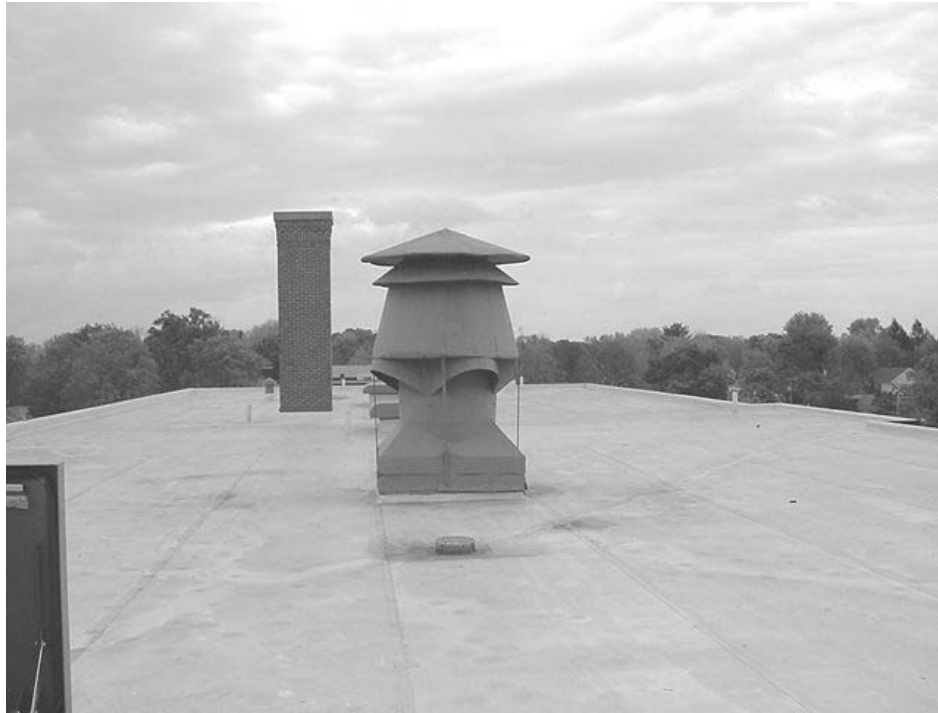
Picture 9

Housing for Possible Mechanical Exhaust Ventilation Fan on the 1925 Wing Roof

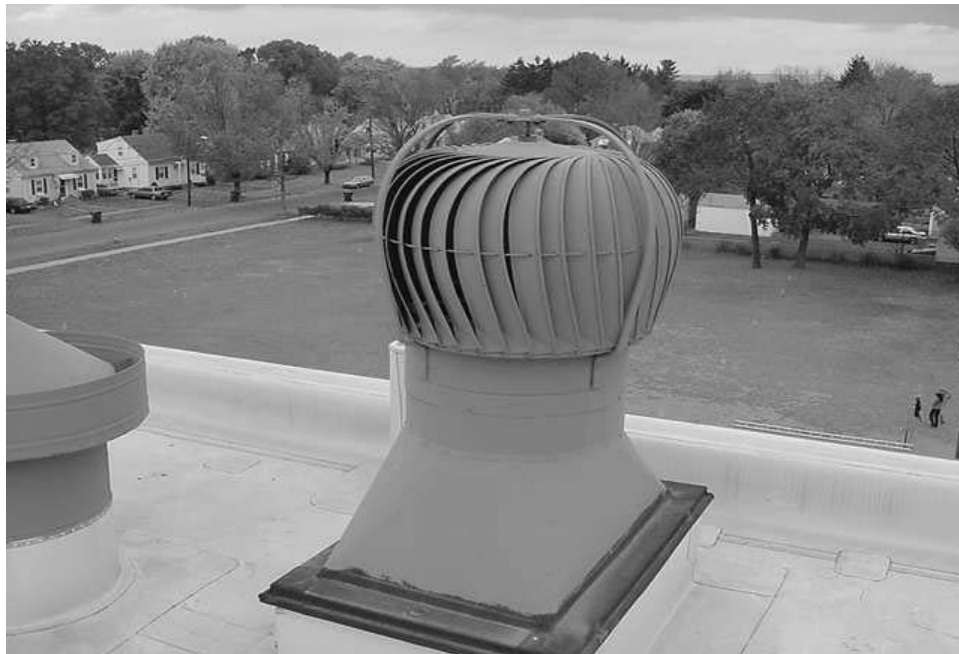
Picture 10

Frozen Turbine Fan on the 1925 Wing Roof

3. Examine the unit exhaust ventilators for function. If broken, repair. Operate each of these units in concert with univents.
4. Repair frozen turbine exhaust vent on roof.

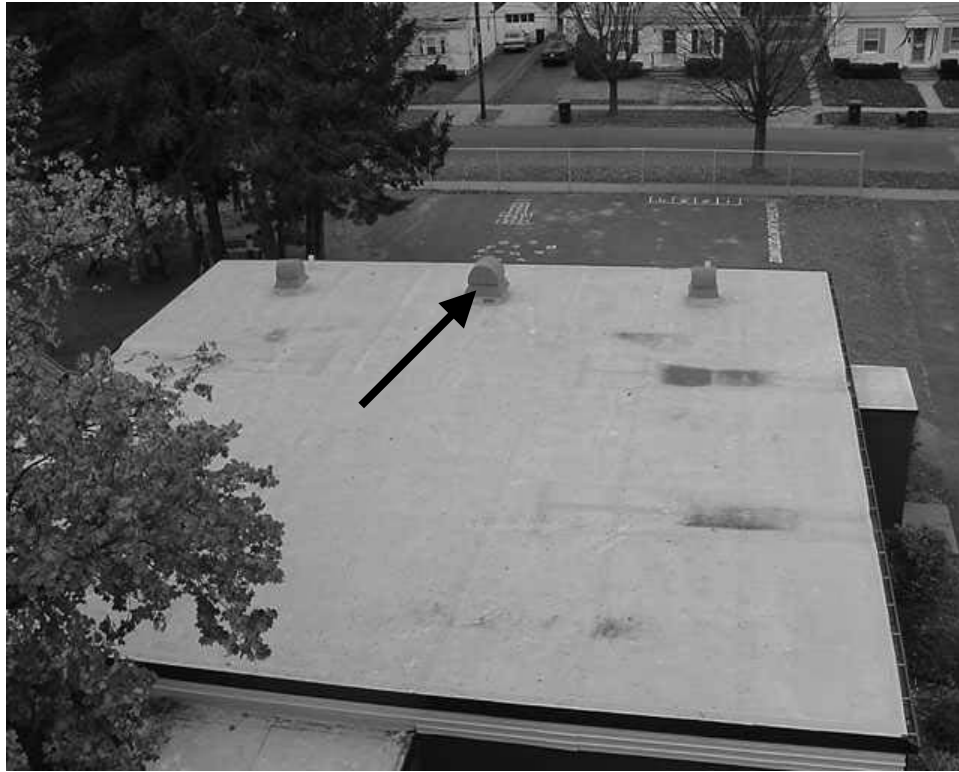
Picture 13

Exhaust ventilation in the 1960s wing consists of wall-mounted vents connected to rooftop exhaust motors via ductwork (see Picture 13). No draw of air was noted in these vents, indicating that the exhaust fans are either broken or deactivated.

Exhaust Vent Terminus on the 1960s Wing Roof

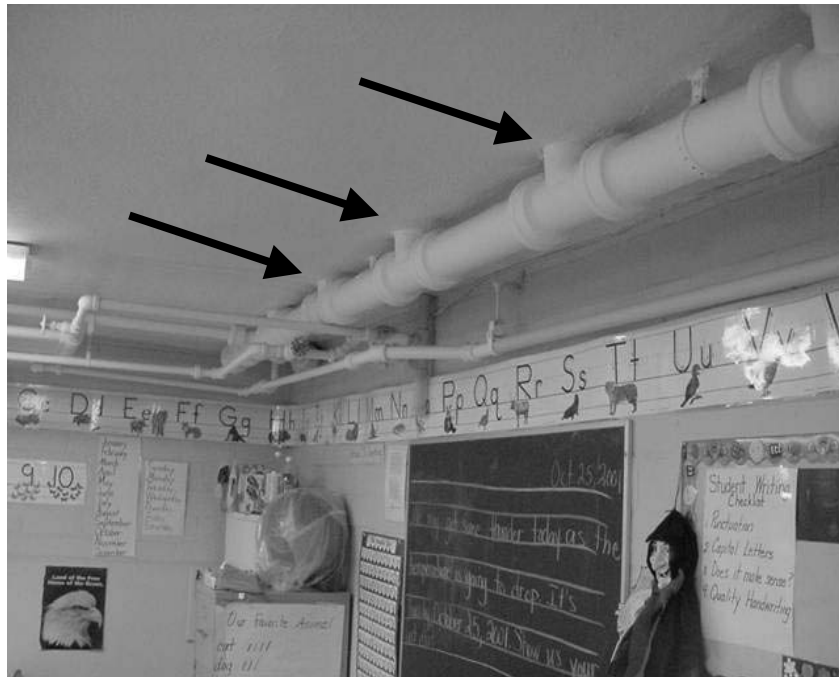
Picture 14

Classroom A in the basement had water-damaged wall plaster, indicating leaks from plumbing in the restrooms on the first floor (see Picture 14). Water-damaged wall plaster can provide a medium for mold and mildew growth, especially if wetted repeatedly. These materials should be repaired/replaced after a water leak is discovered.

Water Damaged Ceiling Plaster around Restroom Drain Pipes in Classroom A

9. Repair/replace water damaged plaster, examine surrounding non-porous areas for mold growth and disinfect with an appropriate antimicrobial if necessary.

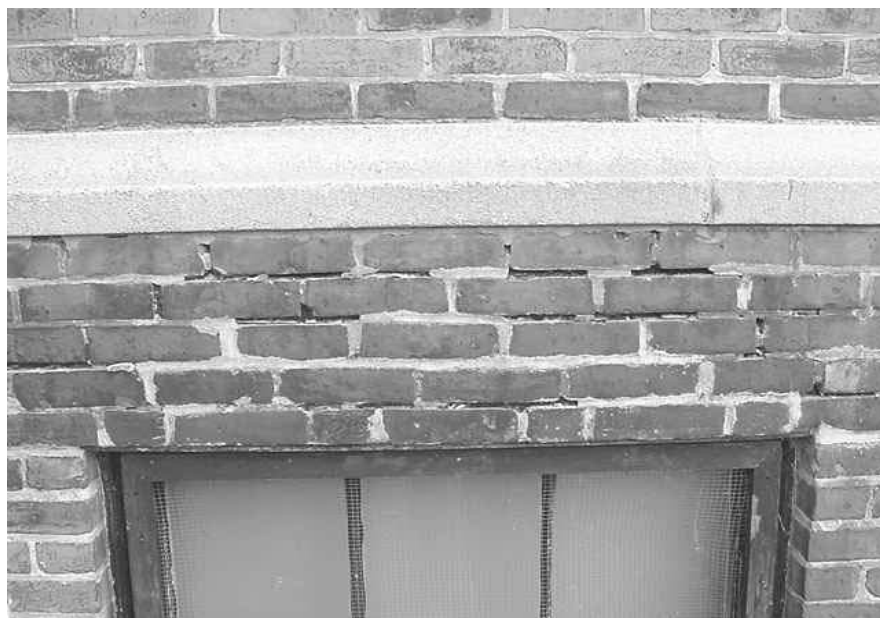
Picture 15

A number of exterior wall conditions would tend to make the building susceptible to water penetration from rain. Some brickwork on the north exterior wall of the 1925 wing is missing mortar (see Picture 15). Damaged exterior brick can lead to increased water penetration that can damage window frames and interior plaster.

Missing Brick Mortar on North Exterior Wall of 1925 Wing

6. Consider having exterior brick re-pointed to prevent further moisture penetration and subsequent water damage.
7. Obtain blueprints (if available) of the original building to determine the configuration of the exhaust ventilation in the 1925 wing. Once the configuration is identified, consider consulting a ventilation engineer concerning the best method to reactivate exhaust ventilation in this wing.

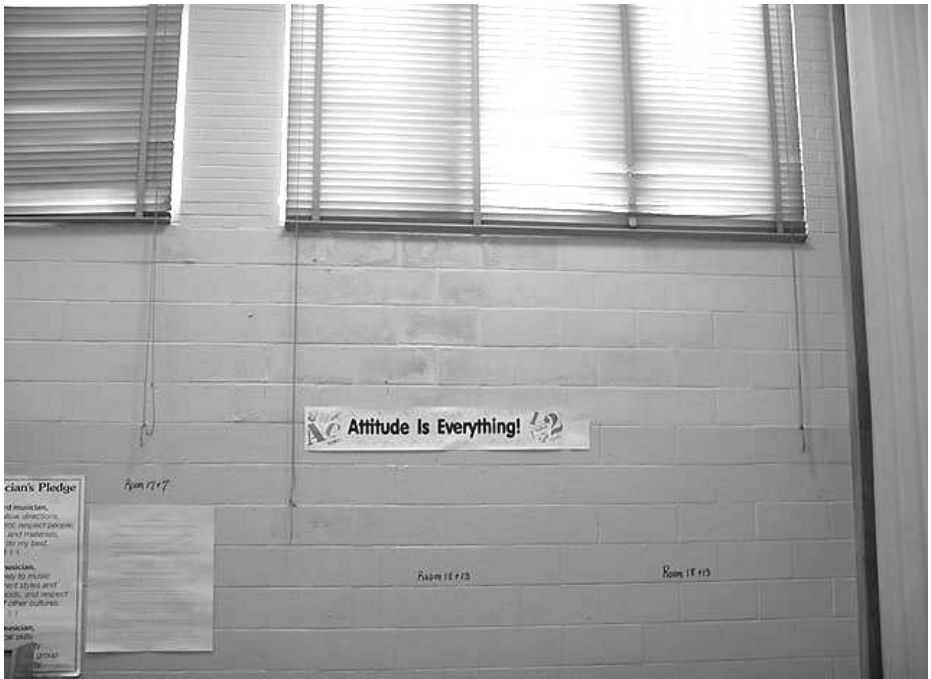
Picture 16

The south wall of the cafeteria shows signs of efflorescence (i.e. mineral deposits) (see Picture 16). Efflorescence is a characteristic sign of water intrusion. As moisture penetrates and works its way through mortar around brick it leaves behind mineral deposits. This condition indicates that water from the exterior is penetrating into the building.

Efflorescence on Cafeteria Wall

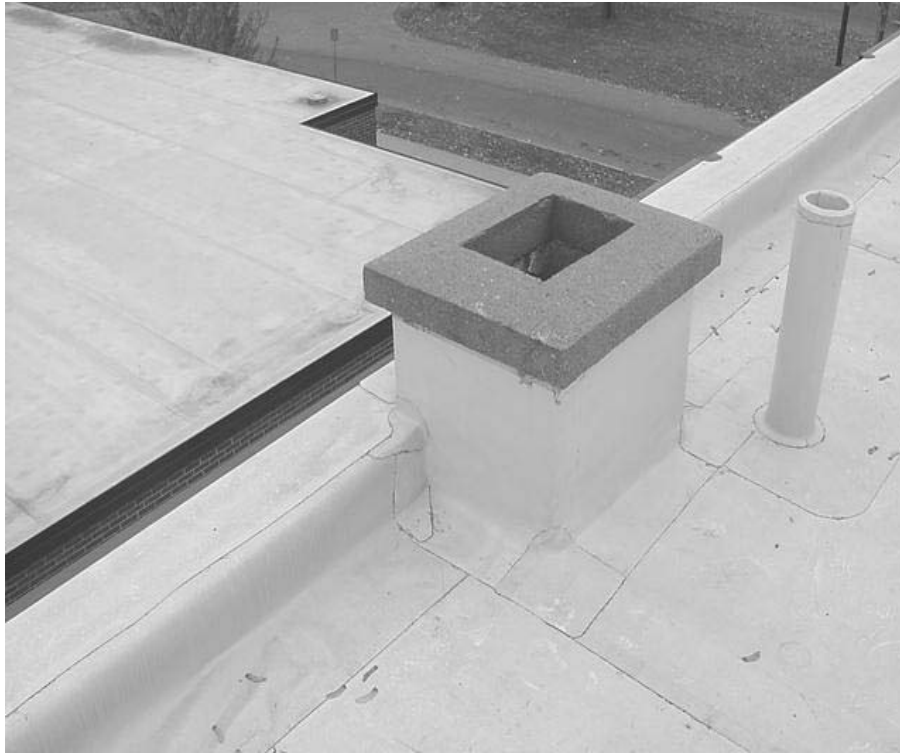
Picture 18

A fireplace exists in the library (see Picture 17) which appeared to be no longer in use. The chimney for the fireplace exists on the roof (see Picture 18). The top of the chimney is open, which can allow rainwater to penetrate down the shaft. In addition, animals may also enter the building through the chimney.

Chimney for Library Fireplace

6. Cut back shrubbery a minimum of three feet to prevent water impingement on exterior brickwork.
7. Seal the abandoned library chimney at roof level to prevent rainwater penetration and animal egress.

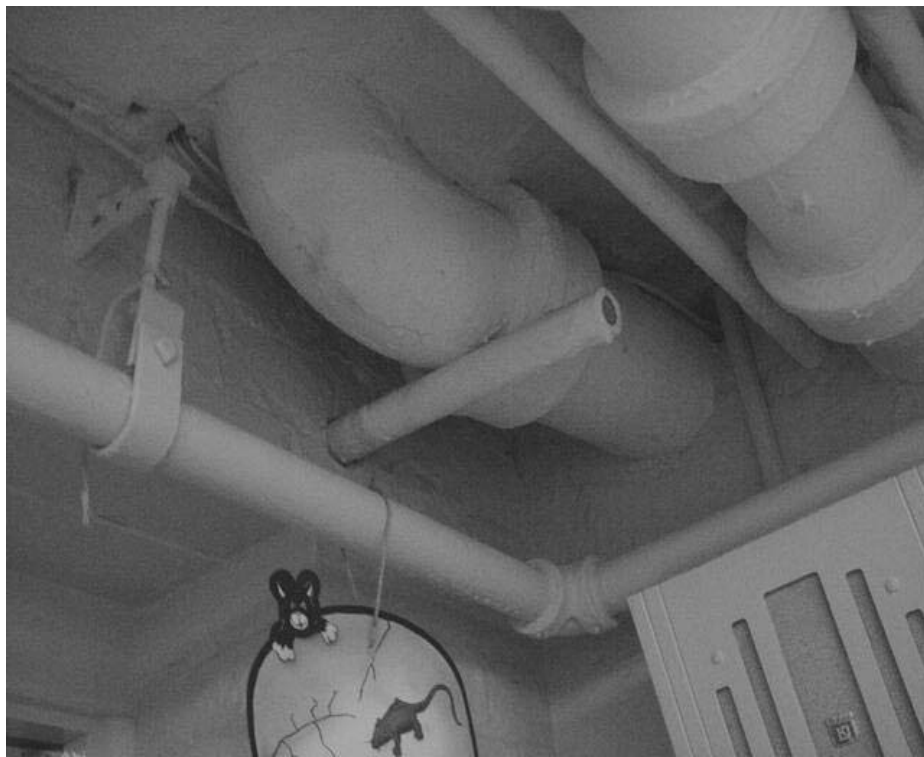
Picture 19

Open Pipe in Classroom A

10. Clean chalkboards and trays regularly to prevent the build-up of excessive chalk dust.
11. Seal the seams in crawlspace access doors with weather-stripping and a door sweep.
12. Seal all abandoned pipes and ducts in basement classrooms.
13. Implementation of the principles of integrated pest management (IPM) is highly recommended for the removal of pests. A copy of the IPM recommendations are included with this report as (MDFA, 1996).
14. Ascertain whether the pipe wrap in Picture 21 contains asbestos and, if so, encapsulate or remove in conformance with Massachusetts law.

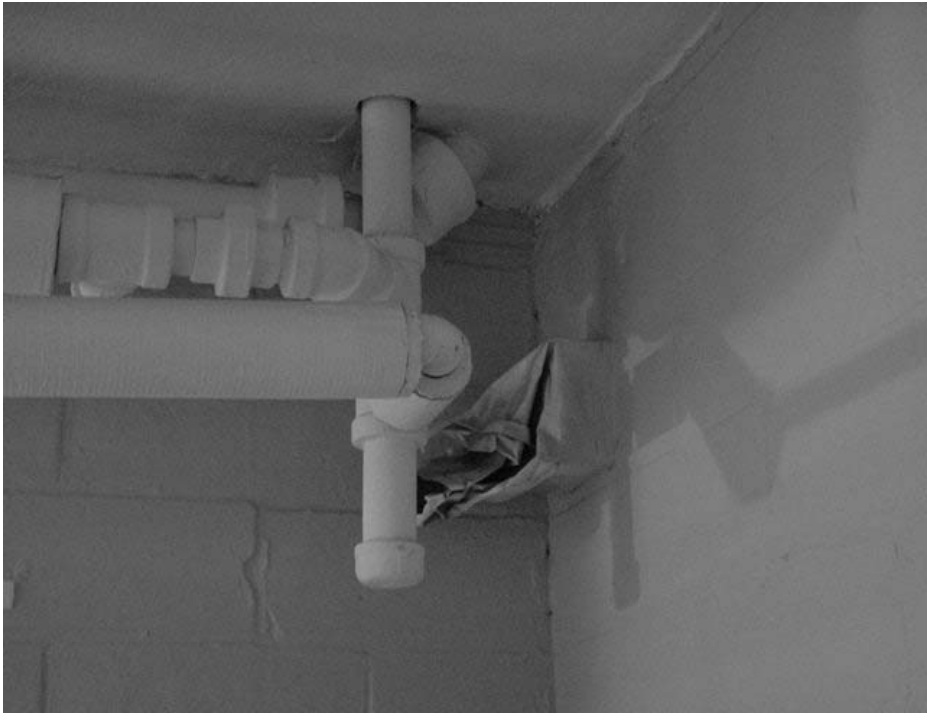
Picture 20

Abandoned Duct in Classroom B

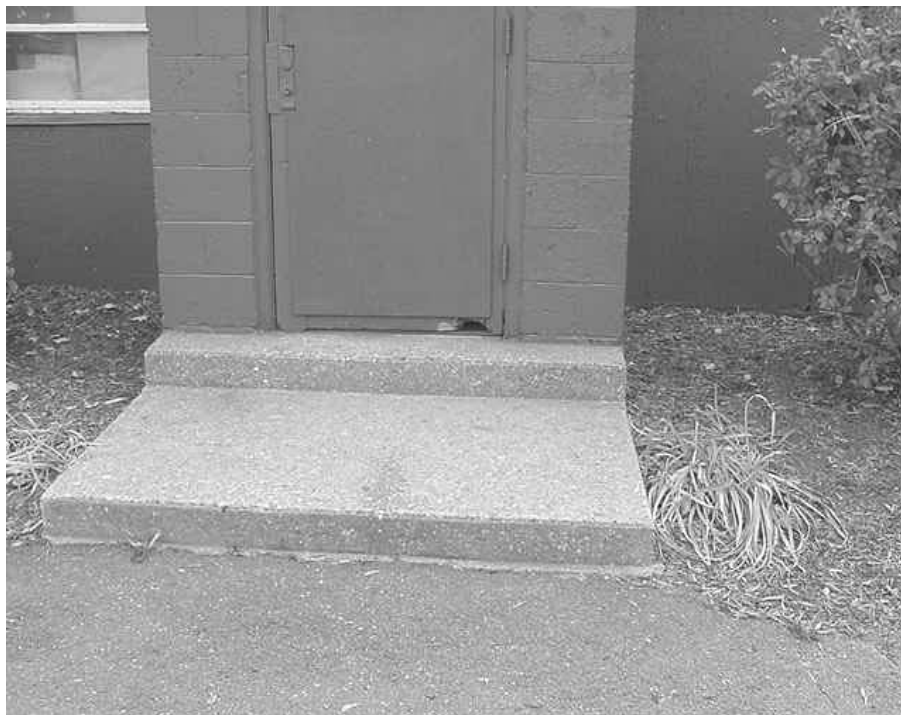
Picture 21

The building has means for pests to penetrate into the building. A hole exists in an exterior door for the 1960s wing (see Picture 21). To penetrate the exterior of a building, rodents require a minimal breach of ¼ inch (MDFA, 1996). Rodent infestation results from easy access to food and water in a building. Rodent infestation can result in indoor air quality related symptoms due to materials in their wastes. Mouse urine contains a protein that is a known sensitizer (US EPA, 1992). A three-step approach is necessary to eliminate rodent infestation:

Hole in 1960s Wing Exterior Door

1. removal of rodents;
2. cleaning of waste products from the interior of the building;
3. reduction/elimination of pathways/food sources that are attracting rodents.

To eliminate exposure to allergens, rodents must be removed from the building. Please note that removal, even after cleaning, may not provide immediate relief since allergens can exist in the interior for several months after rodents are eliminated (Burge, 1995). A combination of cleaning, and increasing ventilation and filtration should serve to reduce rodent associated allergens once the infestation is eliminated. Under current Massachusetts law effective November 1, 2001, the principles of integrated pest management ([IPM](#)) must be used to remove pests in schools (Mass Act, 2000).

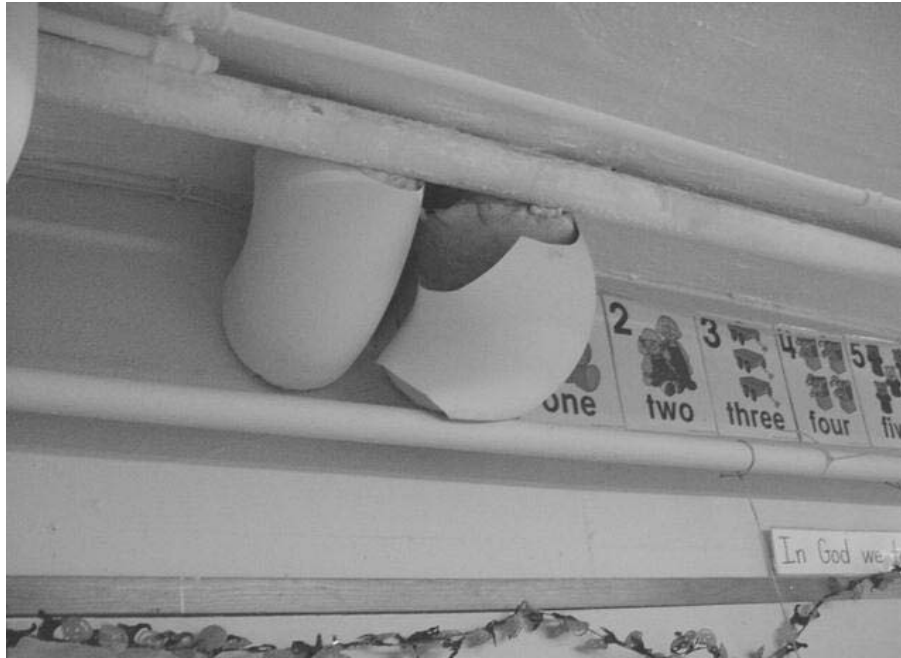
Picture 22

An open pipe elbow with exposed insulation was found in the basement classrooms (see Picture 22). A determination should be made as to whether the insulation material contains asbestos. If so, it should be remediated in conformance with all applicable Massachusetts asbestos abatement and hazardous materials disposal laws.

Open Pipe Wrap Elbow in Classroom A
